## GROUTING AND SHAFT SINKING THROUGH WATER-BEARING GROUND

A.V. Ayugat, Jr., Shaft Superintendent  
**UNITED PARAGON MINING CORP.**  
J.H. Aquino, U/G Geology Head  
**UNITED PARAGON MINING CORP.**  
P. White, P.Eng., Grouting Specialist  
**MULTIURETHANES LTD.**

### Abstract

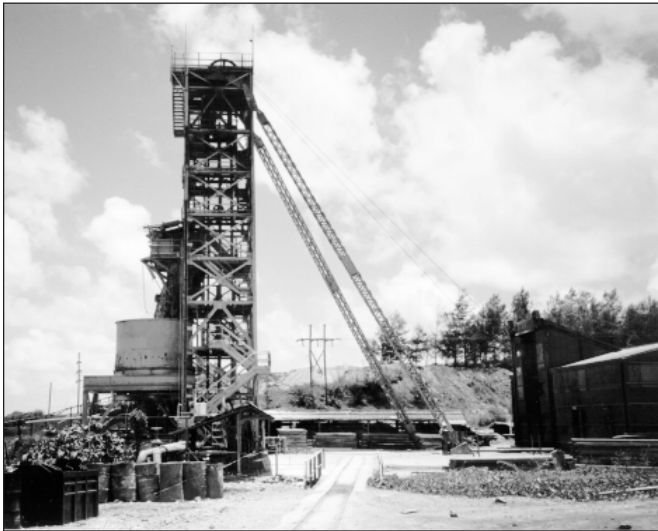
**FIGURE 3 - NO. 4 SHAFT**

The Longos Vein occurs as a fault zone which outcrops into the floor of the Pacific Ocean and accounts for the majority of the 3000 GPM of seawater which is continuously pumped from the mine workings. The Longos Vein was previously mined by a number of shallow shafts and by an open pit. Current mining operations are undertaken through the No 4 Shaft, the last remaining accessible shaft on the property, which stops at a depth of 240 m below surface.

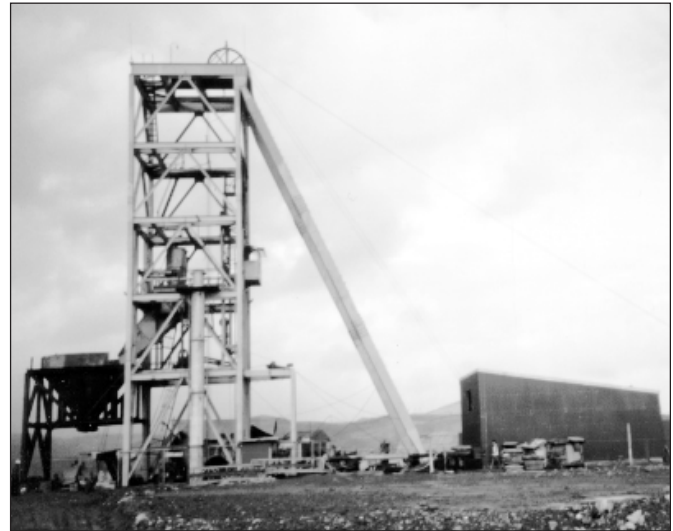
**FIGURE 4 - MAINSHAFT**

The Mainshaft flooding was a direct result of grouting methods and procedures which were inappropriate to site conditions. Grout holes were not flushed clean of drilling debris and mud infillings, nor was water pressure testing undertaken. The holes were grouted to full depth in one pass, rather than using a stage down drilling and grouting technique. Grout injection pressures were too high (1000 - 2000 psi) for the weak, highly-fractured ground conditions.

The use of excessive grouting pressures further weakened the rock formation adjacent to the shaft and caused the shaft bottom to blow out. Seawater entered the shaft and rose at the rate of 12 m per hour until the shaft had filled to sea

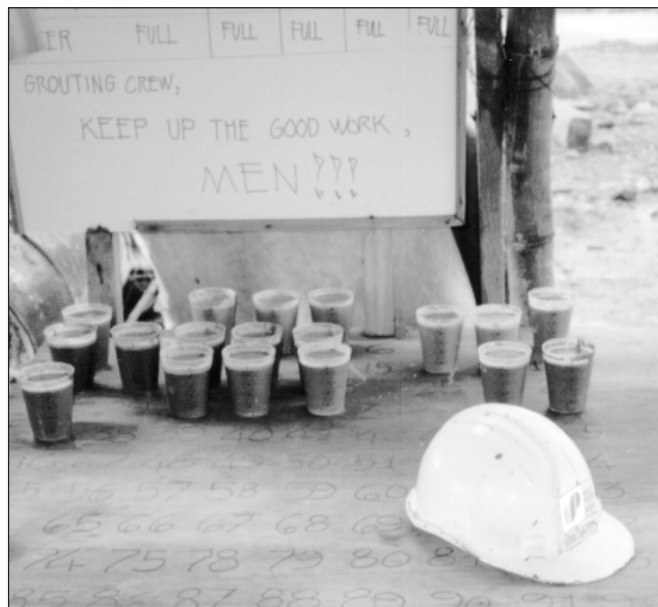
**FIGURE 9 - QUALITY CONTROL STATION**

A quality control station was established adjacent to the colloidal mixer and each batch of grout was routinely sampled for various performance measurements (S.G., Marsh flow time, bleed) and to monitor the rate of curing, as shown in Figure 9.

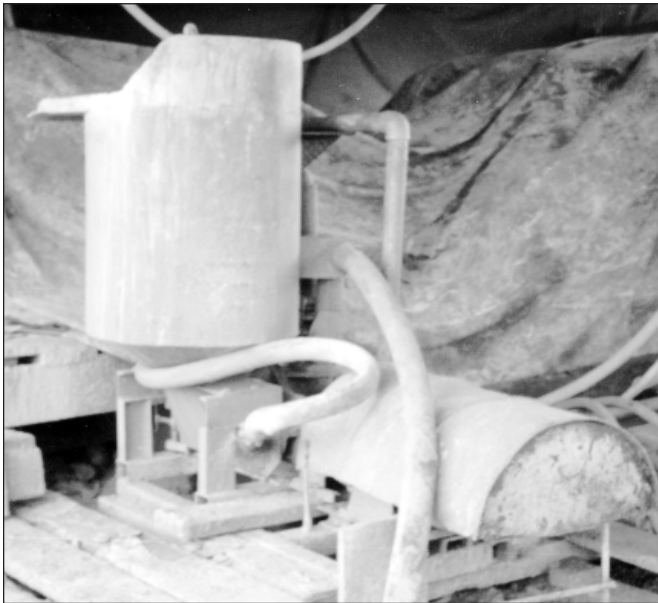
**FIGURE 10 - COLLOIDAL GROUT MIXER**

A high-shear, Concrete-type, colloidal grout mixer was located on surface adjacent to the shaft collar, as shown in Figure 10. This unit had a tank capacity of 6 cubic feet and was driven at 1750 RPM by a direct-connected 15 HP electric motor. A 2 inch water line was used to supply the colloidal mixer with 35 C salt water from the mine dewatering pump line. This unit was able to maintain grout production up to 80 liters per minute.

The colloidal mixer discharged into a site-fabricated, 300 liter agitator tank equipped with a strainer basket, rotating paddles and stationary baffles. This unit was operated by a compressed air motor.

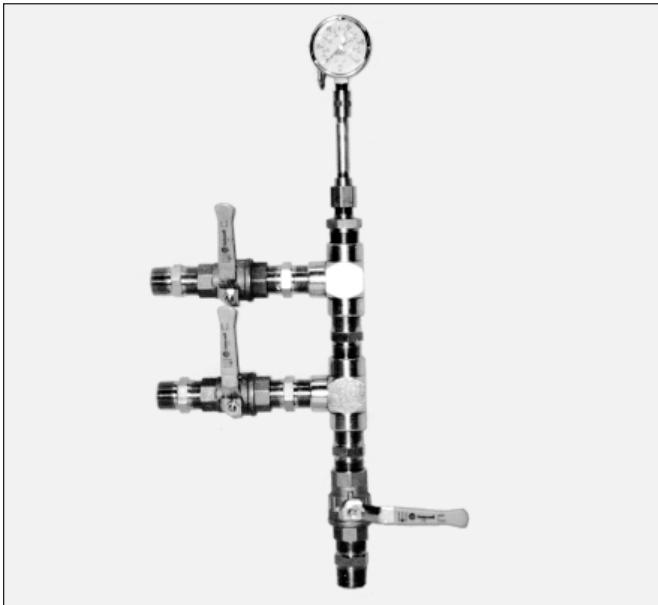
**FIGURE 14 - STANDPIPE FITTINGS**

Standpipe fittings, as shown in Figure 14, were connected to the various types of grout plugs prior to hooking up grout hoses. The use of multiple valve standpipe fittings allowed for pressure relief and flushing of grout hoses at any time during the grouting operation without disconnecting grout hoses from the header. Several grout plugs could be grouted at the same time by connecting hoses between adjacent grout plugs.

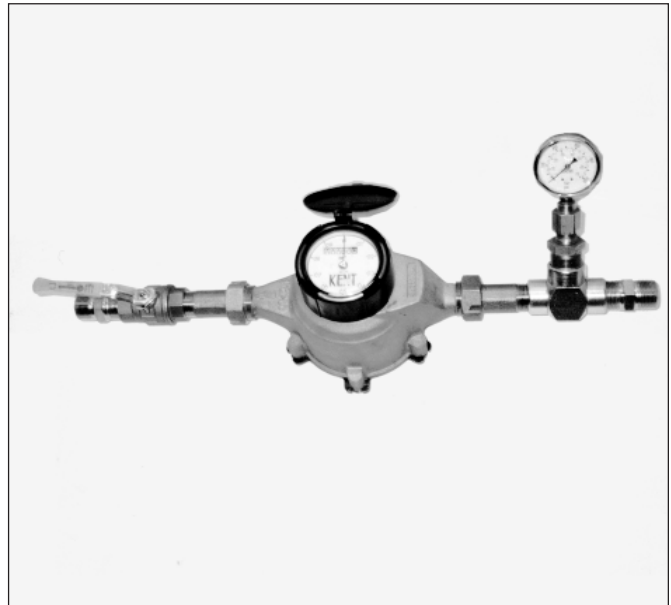
**FIGURE 15 - WATER PRESSURE TEST METER**

A conventional 1 inch dial-face water meter, as shown in Figure 15, calibrated in liters was used to undertake water pressure tests prior to grouting operations. This water meter was connected to a manifold containing a pressure gauge on the upstream side and was hooked up to the grout hole to be tested. The static and dynamic pressures were measured along with the flow rate by allowing ground water to flow through the meter. LUGEON values were calculated and used in the selection of the appropriate grout formulation to accommodate site conditions.

Following drilling of grout holes and installation of grout plugs, water pressure tests were conducted and LUGEON values were calculated for each hole. A sequence of grouting operations was established based on site conditions and the number of grout holes available. Hose connections were hooked up in advance with the shaft bottom header bypass valve open and the discharge valves closed. After all preparations had been made on the shaft bottom, a signal was then given to the colloidal mixer crew on surface to start mixing an appropriate grout mix based on the water pressure test results.
